# Manhole Inspection Summary

Manhole # S19M\_\_048MH

Insp Date: **2/24/08 9:07 AM**

**Location** Address: **349 ashton st**

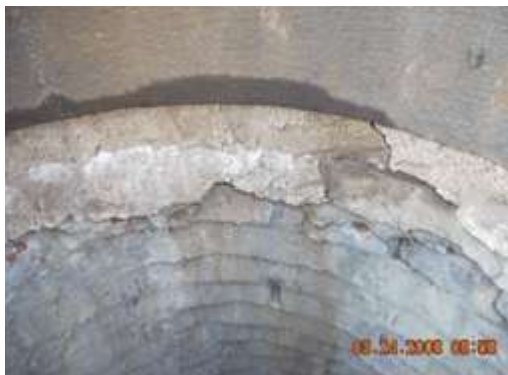
Defect 3

Infiltration: ☐ None ☒ **Joint** ☐ Cracks ☐ Mortar ☐ Roots ☐ Wall

infiltration @ chimney joint

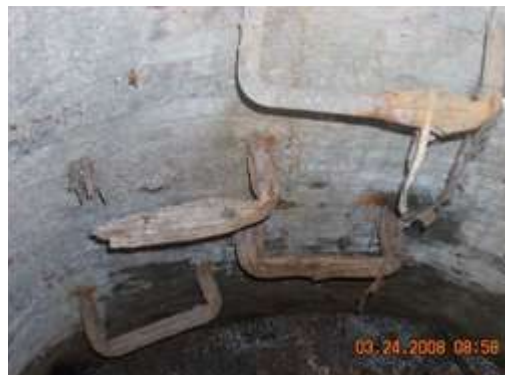
Defect 2

Count: **4** Missing: **0** ☒ **Corroded**

corroded steps

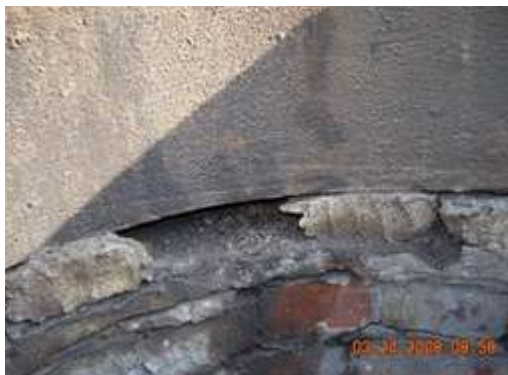
Defect 1

Condition: ☐ Sound ☒ **Cracked** ☐ Root Intrusion ☐ Loose Brick ☒ **Deteriorated**

Cracked and deteriorated chimney

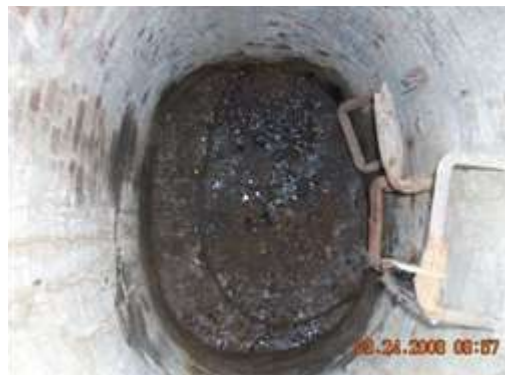
Defect 4

Condition: ☐ Sound ☐ Cracked ☐ Root Intrusion ☐ Deteriorated ☐ Leaks ☒ **Debris**

Channel debris

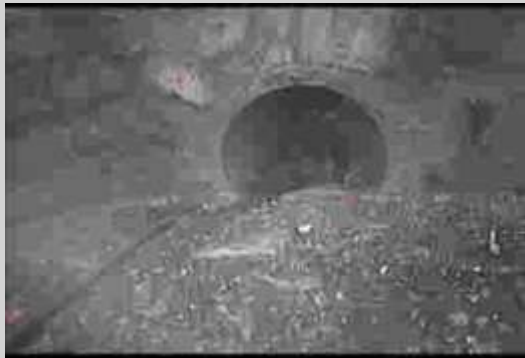
12 O'Clock Outflow

8 in. Circular Gravity Sewer  
Pipe Out @ 12 O'Clock

Deposits: ☐ None ☒ **Mud** ☐ Sludge ☐ Debris ☐ Grease

Silt Depth: **2** (in.) Deposits Extent: **Light**
